# 3D TRASAR™ Technology improves cooling water efficiency resulting in financial, operational and environmental improvements at a petrochemical plant

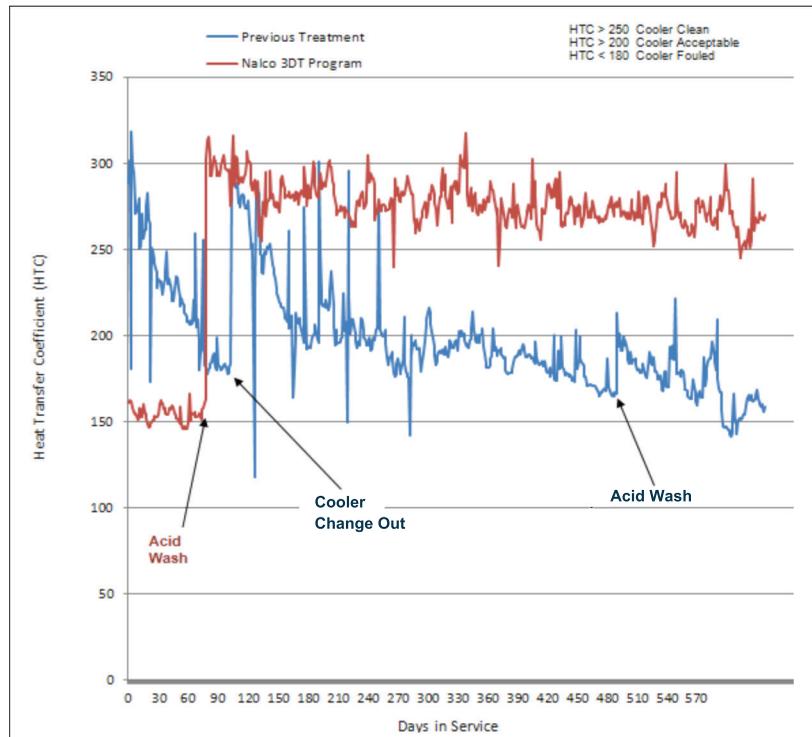
**Figure 1** - Nalco 3D TRASAR technology ensures reliable operation of critical cooling systems with a 38% improvement in U coefficient.

Once the program was implemented, exchanger fouling was significantly reduced. Plant heat exchanger U coefficient data confirmed this and is shown in Figure 1. The new program demonstrates better control in critical heat exchangers. Using Nalco's sophisticated computer modeling and real time system monitoring and control, the team was also able to safely increase the cycles of concentration providing the plant with significant water savings. Once 3D TRASAR automation was installed new, otherwise unknown information became evident. By trending changes in the circulating water turbidity it was determined the side-stream filter was not working properly contributing to high circulating water turbidity. The filter was repaired and the problem was corrected.
